COMPRESSOR FOULING DETECTION BY IMAGE ANALYSIS

ABSTRACT

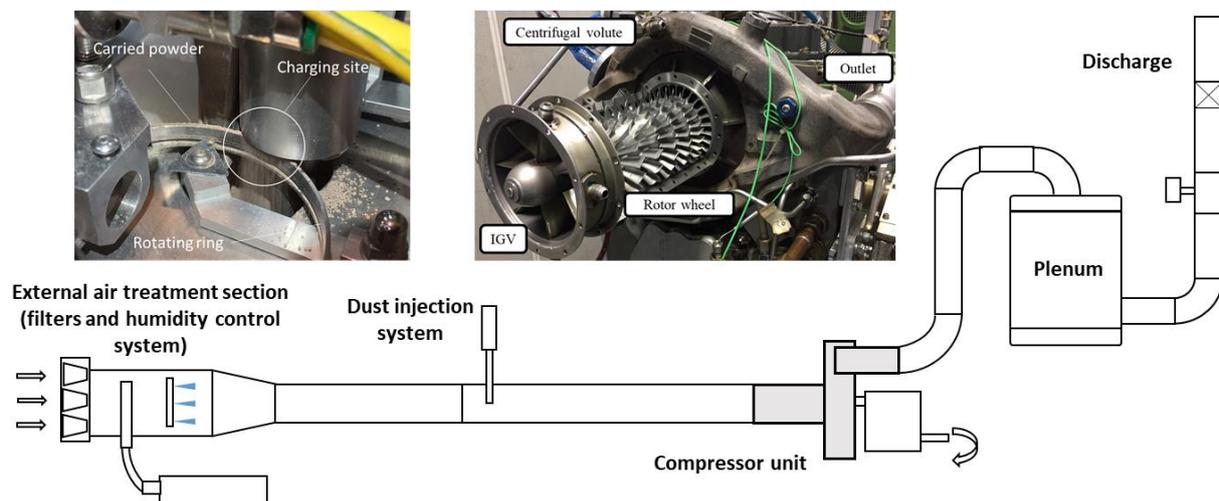
Figure 1. Test bench

According to Fig. 1, the test bench is equipped with an external air treatment section, which allows the setup of the relative humidity at the compressor inlet, and a contaminant injection system, able to disperse micro-sized particles in the airflow swallowed by the unit. The particle feeder is the TOPAS SAG40U, able to prepare and inject the solid contaminants with two Venturi eductors, guaranteeing the proper particle injection process. The contaminants were dosed using a variable-speed rotating ring to increase or decrease the mass per unit of time prepared for Venturi's sucking process. The dosing system and the setup of the contaminant injection are described in [16].

range of (15 – 80) %RH. Table 1 shows the tested conditions. The fouling tests cover the upper half-plane of the overall design. Each test had a duration of 4 hours. The powder concentration was kept constant and equal to 6 mg/m³ for all the tested powder by adjusting the ring speed of the feeder (see Fig. 1 for more details).

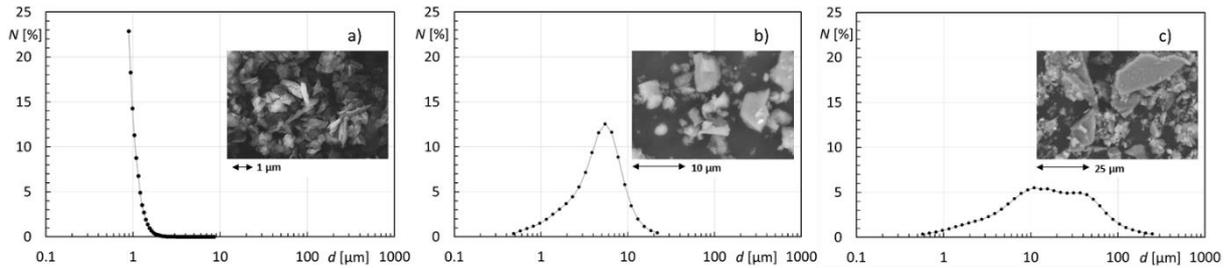
Figure 2. Particle diameter distributions: a) ARD N, b) ARD UF, and c) ARD M

Contaminants. To explore the fouling phenomenon, three powder samples have been considered. In line with the on-field experiences [3], soil particles come from several sources and have different diameters. In particular, the dust carried by the wind covers thousand of kilometers and it is usually characterized by a diameter lower or almost equal to 1 μm . At the same time, bigger soil particles are typically carried by storms for a few kilometers [17, 18]. Therefore, three diameter distributions have been considered to explore the most comprehensive possibility. All of the soil samples are the Arizona Road Dust (ARD) sample, characterized by a density of 2717 kg/m^3 . It is a natural-based powder consisting mainly of about 70 wt. % silica and 14 wt. % aluminum oxide and other minor iron, sodium, calcium, and magnesium oxides. To measure the diameters distribution, the Malvern Microsizer 3000 has been used. The particle diameter distributions for the three powder sample named ARD N ($d_{\text{mean}} = 1.3 \mu\text{m}$), ARD UF ($d_{\text{mean}} = 4.8 \mu\text{m}$), and ARD M ($d_{\text{mean}} = 25.5 \mu\text{m}$) are reported in Fig. 2. In Fig. 2, SEM (Scanning Electron Microscope) detections are reported. Looking at the detections, the soil particles are characterized by an irregular shape and edges. All of

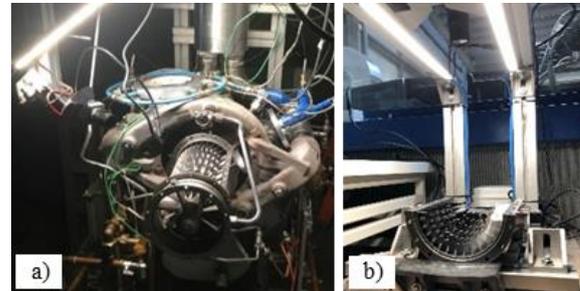
Figure 3. Light and camera setup for a) rotor and b) stator surfaces

The deposit patterns are taken directly from the lab-testing facility employing dedicated cameras with a resolution of 3264 x 2448 pixels positioned to detect the entire flow path of the axial compressor divided according to the rotor and stator components. The white light setup is adopted for both parts of the compressor flow path with the intensity of 4000 K. In Fig. 3, the light setup for rotor and stator surfaces has been reported.

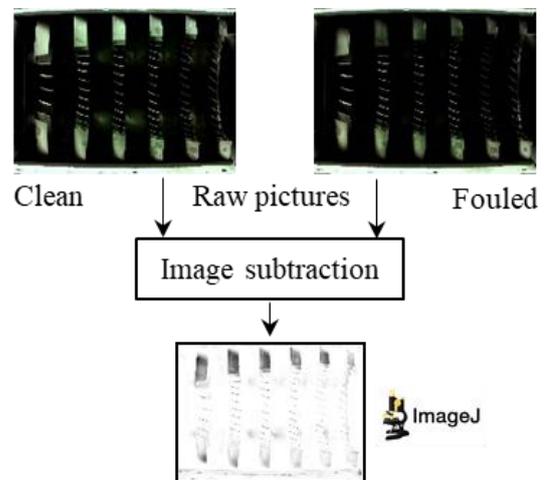
Figure 4. Strategy for the image post process

After the picture collection (clean and fouled conditions), the deposit patterns were determined through image processing based on the open-source package Image J [19] developed by the U.S. National Institutes of Health. The procedure [20 – 22] is based on subtracting the picture of the fouled surfaces and the picture of the clean one converting the resultant image into a binary format. Finally, the picture is converted to show the deposits as the grayscale-colored pattern on the picture. The procedure is summarized in Fig. 4.

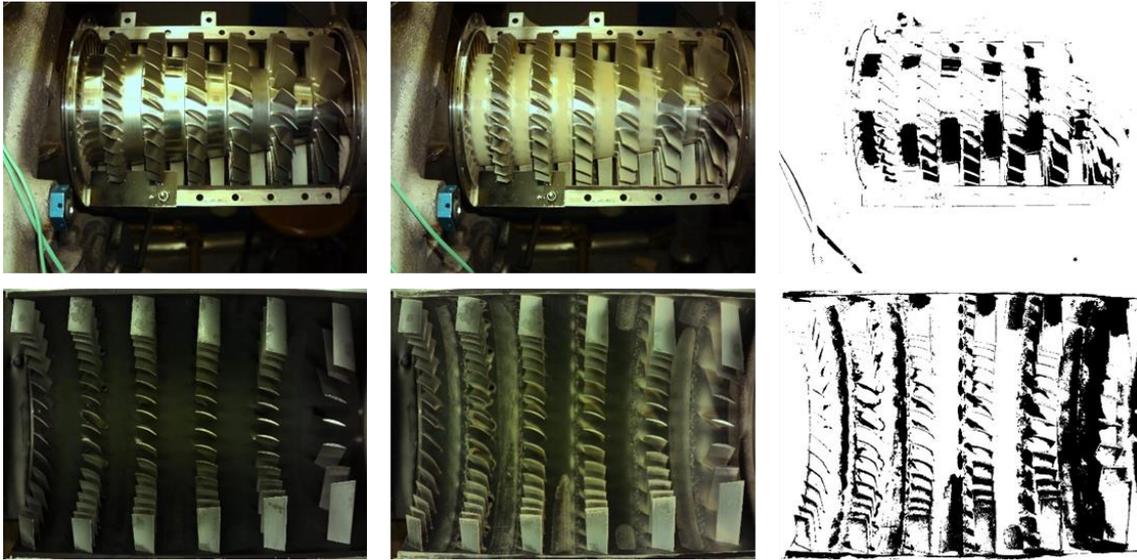
Figure 5. Detections (from left to right the clean, fouled, and post-processed images) for ARD N (15 %RH)

Image detections. Samples of image detections are proposed in Figs 5 – 7. These figures report the results from the deposition tests of ARD N with 15 %RH, ARD UF with 50 %RH, and ARD M with 80 %RH, respectively. The set of image reports from left to right the clean, fouled, and post-processed detections. Concerning a single picture, the front stages are on the right, while the rear stages (axial compressor discharge section) are on the left.

Comparing the clean and fouled detections, it is possible to see the deposition process affecting the blade and vanes surfaces and the hub and shroud surfaces. Increasing the particle diameter, the adhesion process becomes less effective even with greater humidity. A greater deposition can be found in the pressure side of the rotor blade and stator vanes as well as in correspondence of the leading edge. From Figs 5 – 7 is clear that using only the detection, a detailed comparison between the clean condition and the fouled one is not straightforward. In addition, by changing the contaminants, the comparisons became impossible. Based on the subtraction process between "fouled" and "clean" images, the image post-process allows the proper comparison. As seen from the analysis, the image-post process emphasizes the deposits patterns, generating a black and white map useful to consider how different contaminants and operating conditions affect the compressor surfaces. As reported in [23 – 25], the effects of deposits on compressor performance change according to the location on the blade surfaces. For example, the contamination on the suction side of the stator vanes changes over the stage, and only by using the post-processed images has it been possible to quantify. The smallest powder (ARD N) affects all stages, ARD UF affects only the first three stages, while the coarsest powder (ARD M) affects the first two

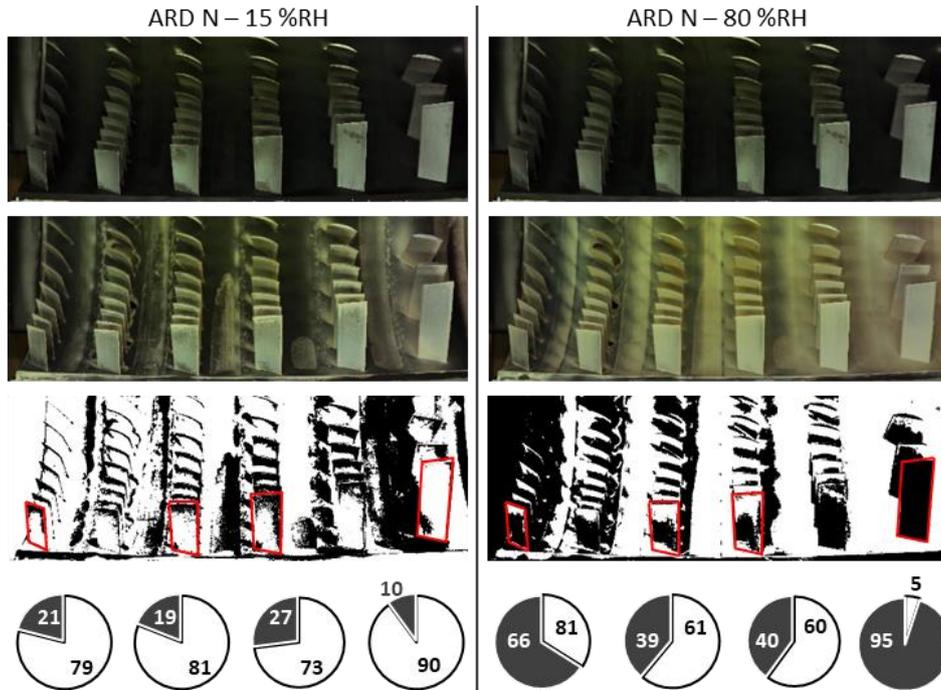
Quantitative analysis. Starting from the post-processed image, a quantitative analysis can be done. The black and white images allow the comparison of the dirty and clean areas on the compressor surface. Figure 8 reports the quantitative analysis of the ARD N test with low and high relative humidity values. The comparison is based on the pixel count of the post-processed images. According to the adopted calculation (see Fig. 4 for more details), black pixels represent the dirty regions while white pixels represent the clean regions. Therefore, comparing the number of white and black pixels and the total pixel, it is possible to estimate the fouled portion of the interested surface. In Fig. 8, four representative pressure sides of the stator vane surfaces have been considered. The regions of interest for each vane have been highlighted with red lines. In these regions, the ImageJ software made a pixel count, and the ratio between white pixels and black pixels to the total number of pixels has been reported in pie charts. The increased humidity values determine more detrimental conditions increasing the adhesion capability of particles. At the same time, looking at the pie charts, a quantitative explanation of the deposits modification over the compressor flow path can be done. Greater humidity determines the greatest contamination of the first stage and a progressive reduction of the deposits. By contrast, for the same operating condition and contaminants, but during a dry period, the compressor experiences more significant contamination on the rear stage instead of the first stage.

Figure 8. Sensitivity analysis to relative humidity for ARD N. The image analysis is dedicated to the pressure side of the stator vanes

Figure 10 reports the mass of the deposits collected in correspondence to the pressure side of the stator vane surfaces. These quantitative measurements correspond to the same surfaces evaluated in Fig. 8. Comparing the analysis carried out by counting the pixel ratio and the collected mass, it can be concluded that the proposed measurement strategy allows an evaluation of the fouling phenomenon over the machine flow path. As can be seen from Fig. 10, front stages resulting from the high-humidity test are characterized by greater contaminant mass, similar to the results shown in Fig. 8. Image detection reveals the fouled area, and for this reason, comparing the deposited mass, some discrepancies could be detected. Looking at the aft stages, the deposited mass indicates that the relative humidity value does not affect the deposition process. By contrast, the image detection shows greater contamination for the test with 80 % RH. In the image detection, the deposited thickness is not detected, and a complete assessment of the deposited mass (i.e., volume) can not be assessed. The Shape From Shading (SFS) technique could represent a step forward in this sense. The SFS allows the obtainment of three-dimensional information starting from a two-dimensional detection. As shown in [29], this technique could be useful to estimate the deposits thickness even if, due to the mathematical constraints, the results have to

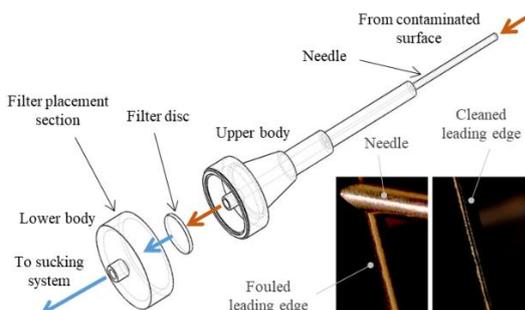
Figure 9. The LAPO system

image analysis. Since image detection could be very effective in the on-filed application, using a lab-scale test, it is possible to define the reliability of the present procedure to represent a proper reference for future applications. To compare the image detection of the deposits (black and white pictures) with the actual intensity of the depots, a procedure reported in [27, 28] has been carried out. Therefore, the deposited dust on the compressor vanes has been measured employing an on-purpose designed device, the Localized Aspirator for Particle Observation (LAPO). The exploded view of the LAPO is depicted in Fig. 9. This device is a tool employed for particle sucking and measurement from surfaces driven by a vacuum pump. The system is based on a stainless steel needle with a diameter of 1 mm, which allows direct particle sucking from the surface of interest. In Fig. 9, the deposit collection from a stator vane leading edge is shown. The reported frames show the leading edge before and after the deposit collection, corresponding to the first passage time of the device. Depending on the stickiness of the deposited layer, a complete deposit

removal can be achieved with multiple passages of the needle. The LAPO is equipped with a filter placement section allowing particle trapping and collection. At the end of the particle collection, the device is unscrewed, and the filter is removed and weighted to calculate the collected powder amount.
